**JONES LAKE DAM**

**OREGON COUNTY, MISSOURI**

**MO 31486**

**PHASE 1 INSPECTION REPORT  
NATIONAL DAM SAFETY PROGRAM**

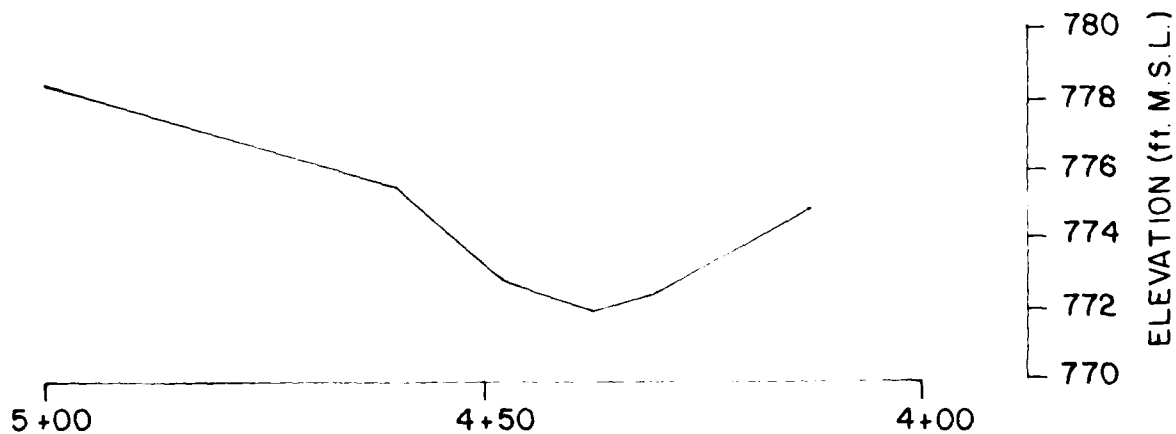
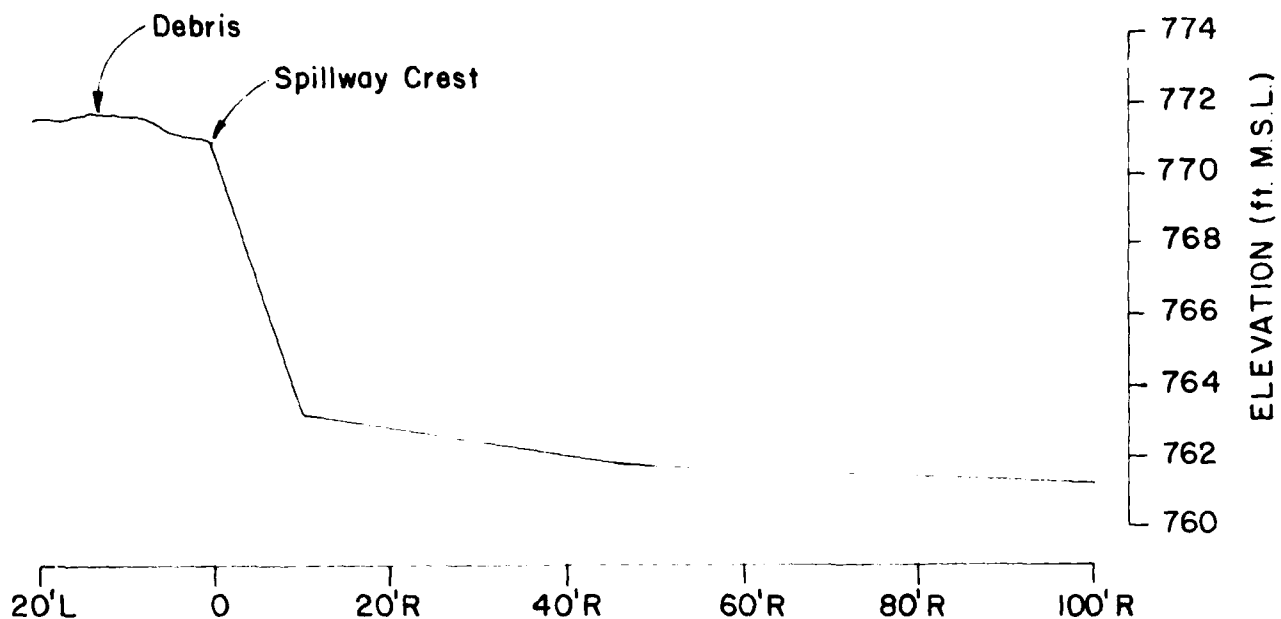
PROFILE & SECTION OF SPILLWAY

Information from the owner indicates that the spillway was originally lined with concrete from about 40 ft upstream of the crest to about 100 ft downstream of the crest. A large portion of this concrete has deteriorated and washed away in the last few years, leaving only a portion of the slab at the spillway crest. The remaining concrete is severely undermined at its downstream end (see Photo 13). The spillway discharge channel has experienced considerable erosion immediately downstream of the crest (see Photos 14 and 15). The spillway discharge channel is fairly clear for about 100 ft before entering a wooded area. It empties into the old streambed below the small pond beyond the toe of the dam.

No evidence of overtopping of the embankment was observed. The approach area to the spillways was filled with silt and wood debris. The concrete slab which protects the spillway section is severely undermined at its downstream end. The outlet channel has experienced significant erosion.

- (1) Seepage and stability analyses comparable to the requirements of the recommended guidelines should be performed by an engineer experienced in the construction of dams.
- (2) The spillway crest area should be provided with a permanent control section, which is protected against undermining. The downstream channel beyond the control section should be protected against erosion.
- (3) The erosion, sloughing, and animal holes on the upstream embankment face should be repaired, and wave protection should be provided.
- (4) Trees and brush should be removed from the face of the dam on an annual basis. The initial clearing should be done under the guidance of a professional engineer experienced in the design and construction of dams. Indiscriminate clearing methods could jeopardize the safety of the dam.

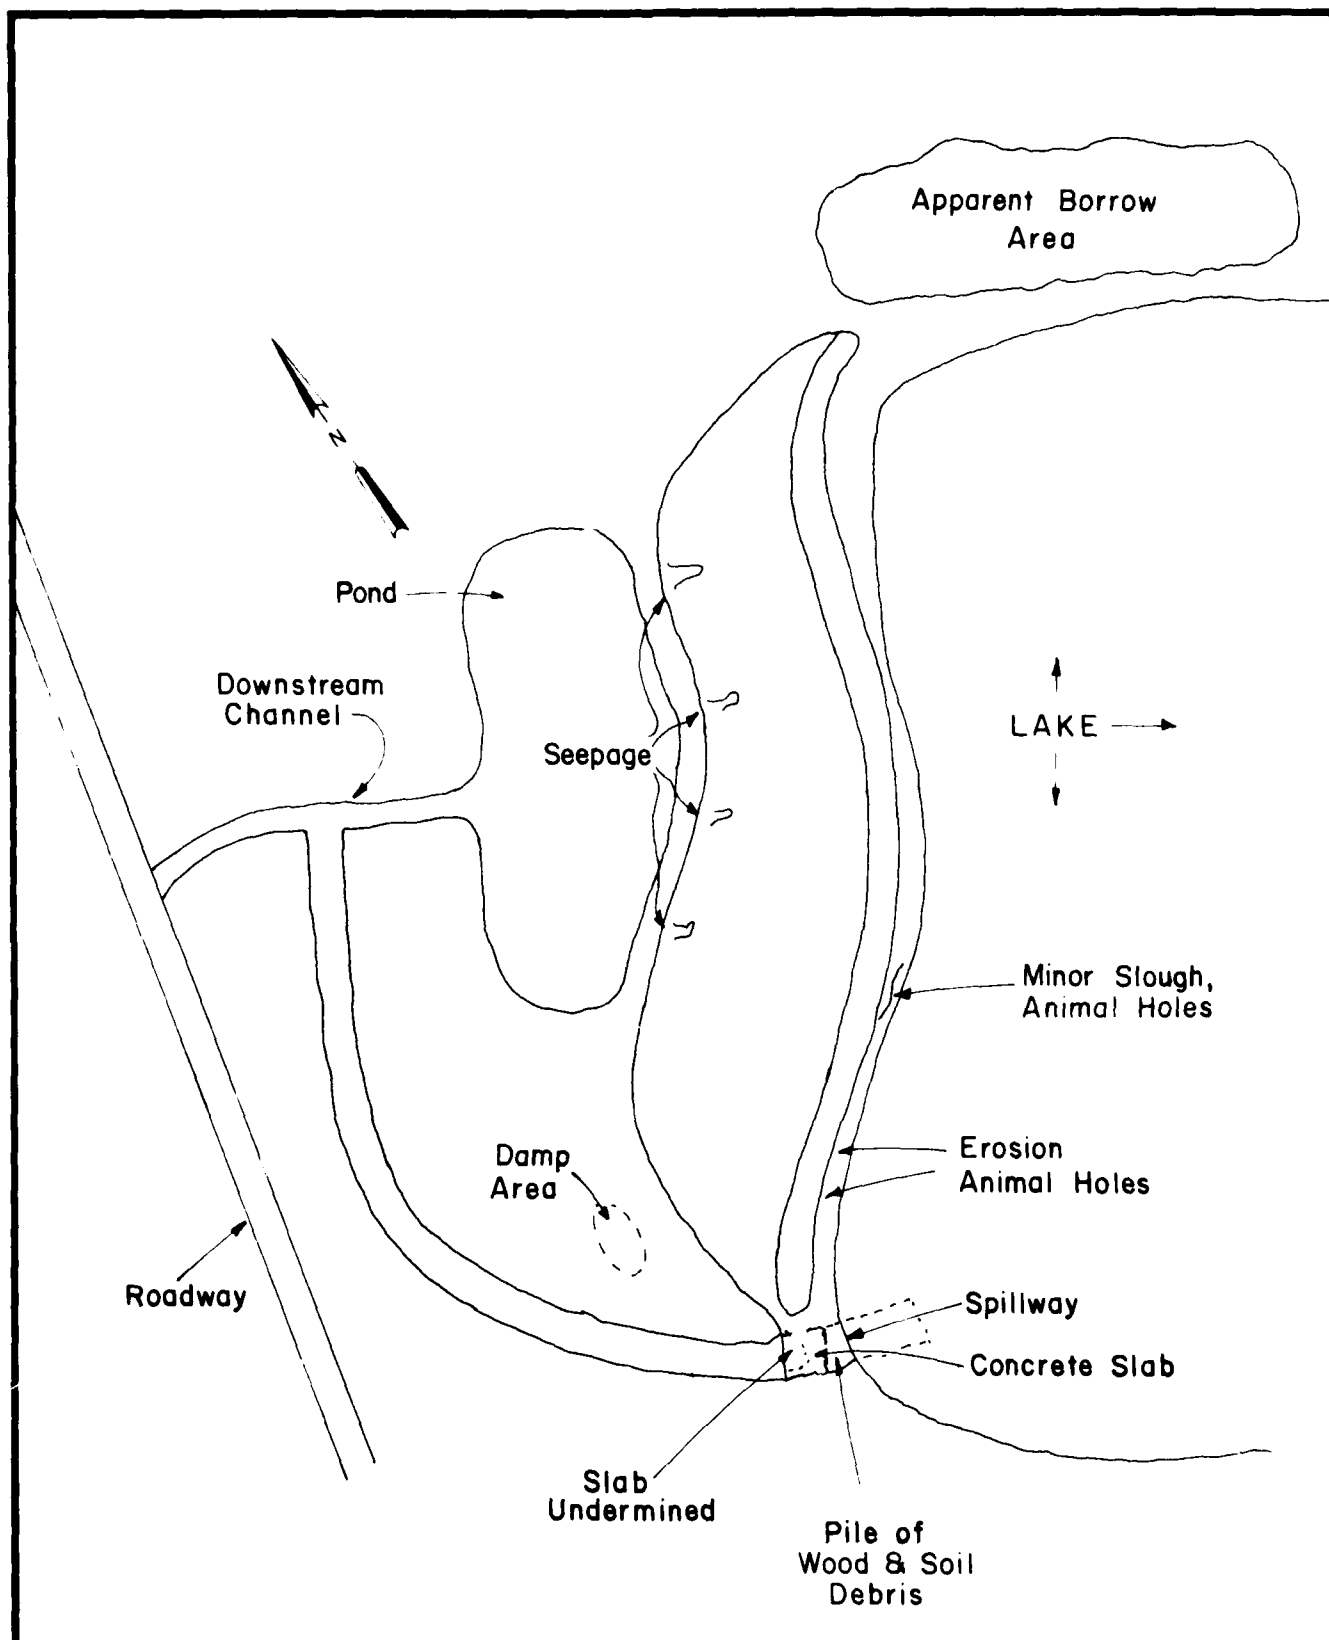
# PLAN FEATURES OF DAM

The vertical alignment of the crest seemed good. The dam was built on a curve (concave upstream), and no surface cracking or unusual movement was obvious. The presence of a pond at the downstream toe precluded inspecting this area for stability and additional seepage problems. The owner reported that the pond was there before the dam was built. Sheet 5 of Appendix A presents a plan sketch of the dam showing observed features.
